ELECTRICAL SUBSTATION
SUSTAINMENT
BASRAH, IRAQ

SIGIR PA-06-082
SIGIR PA-06-083
SIGIR PA-06-084
SIGIR PA-06-085
SIGIR PA-06-086
JANUARY 10, 2007

SUBJECT: Report on Electrical Substation Sustainment, Basrah Iraq
(Report Numbers SIGIR PA-06-082, 083, 084, 085, and 086)

Electrical Substation Sustainment Basrah, Iraq

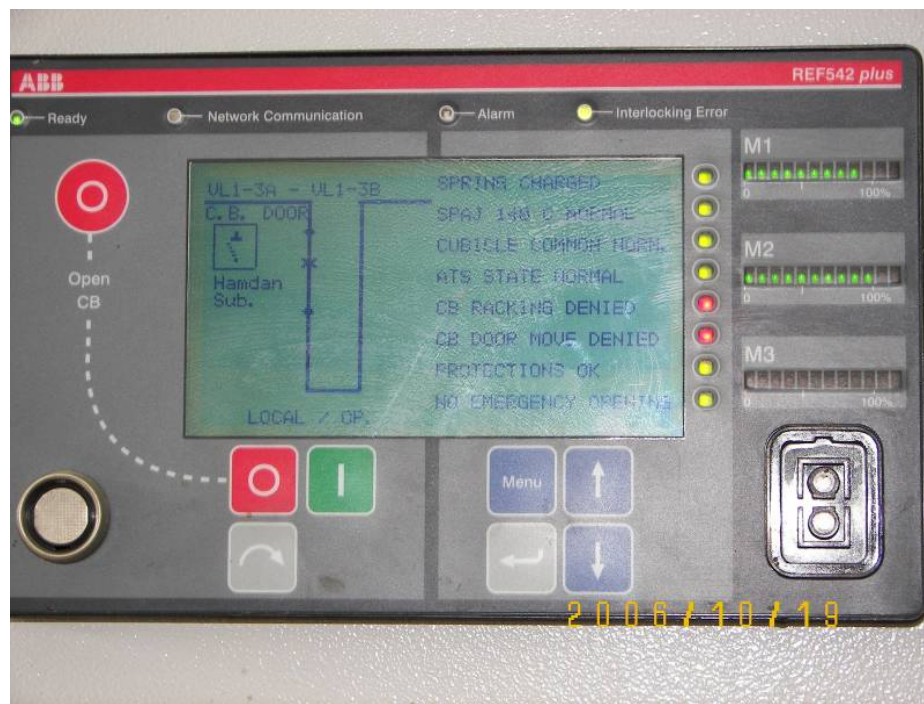
Site Photo 1 is a panel display showing the closed circuit that is energizing a distribution circuit.

Site Photo 1. Switch panel display illustrating the closed distribution circuit

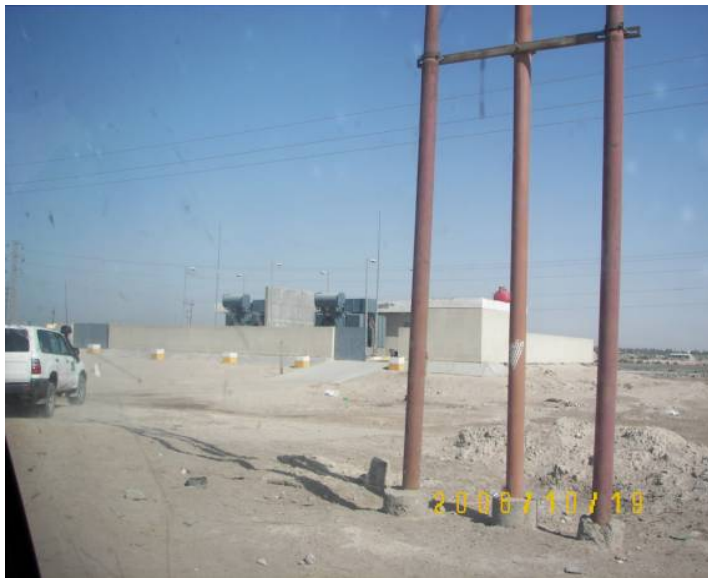
The current sustaining assessment of the Al Seraji and Al Hamdan substations showed that the substation buildings, guardhouses, and perimeter walls remained in good repair. Each substation was secured by security guards and two substation operators, who were present at the time of our visit. Site Photo 2 illustrates the condition of the exterior perimeter of the Al Hamdan substation at the time of our visit. Site Photo 3 illustrates the condition of the interior perimeter walls and transformers at the Al Seraji substation.

Site Photo 2. Al Hamdan substation perimeter walls

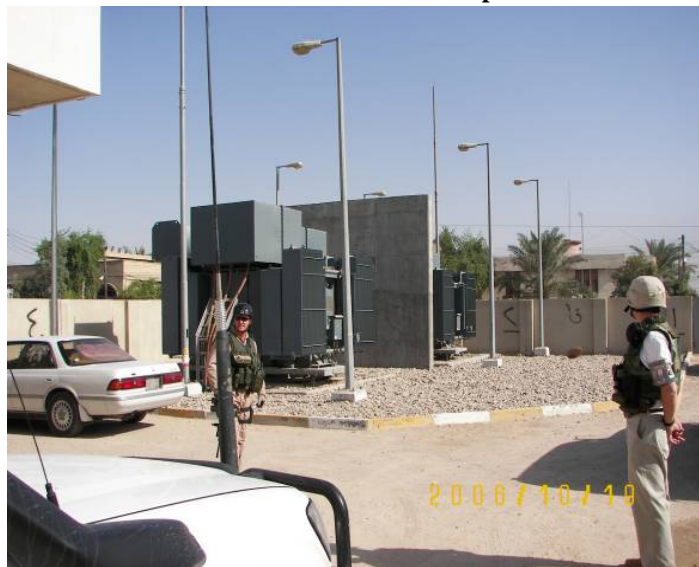
Site Photo 3. Al Seraji substation view of internal walls

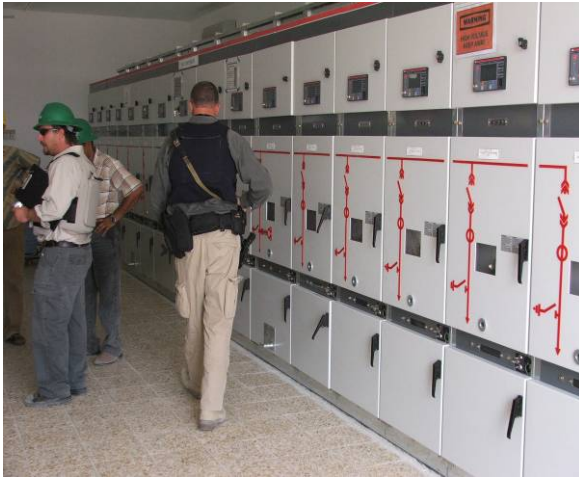
Site Photo4. Al Hamdan substation distribution 11 kV switchgear panels at the time of the initial assessment

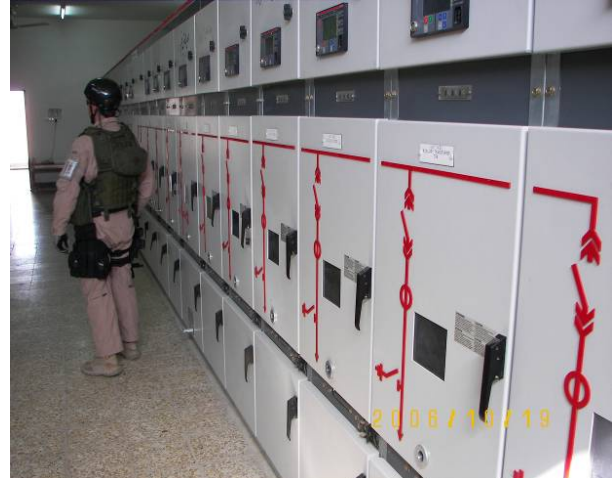
Site Photo 5. Al Hamdan substation distribution 11 kV switchgear panels at the time of the second assessment

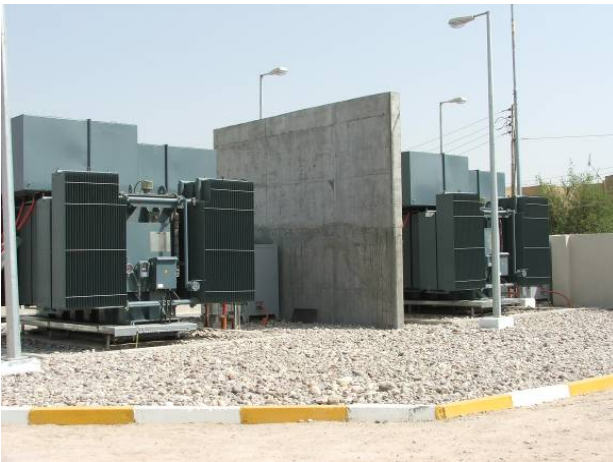
Site Photo10. Al Seraji 33/11 kV transformer at the first assessment

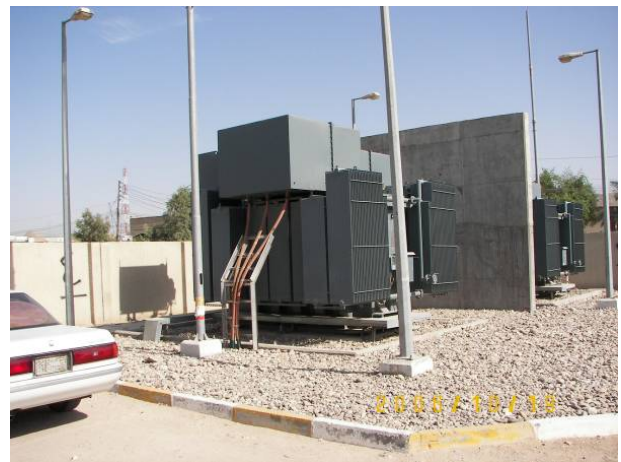
were installed on concrete pads with firewalls. The current assessment confirmed that the transformers remained in good repair and three of the four were operational. The fourth transformer, located at Al Hamdan was connected to the transmission feeder but was not operating because of maintenance being performed at the upstream transmission substation. Site Photos 8 through 11 shows no significant change in the transformers' condition between the first and second assessments.

Site Photo 11. Al Seraji 33/11kV transformer at the second assessment
